USE OF UAV AS A TOOL FOR DAM AUSCULTATION

Abstract. *This study explores the application of Unmanned Aerial Vehicles (UAVs) integrated with digital aerophotogrammetry as a tool for the auscultation of earth dams, focusing on the Chasqueiro Dam, located in southern Rio Grande do Sul. Using a rotary-wing UAV equipped with a high-resolution camera, cartographic products such as orthomosaics and Digital Surface Models (DSM) were generated, enabling the identification of critical elements such as piezometers and gullies on the downstream slope that were not detected during visual inspections. The data analysis allowed for the evaluation of the variability of slope inclinations and the conditions of the dam crest, confirming that its width and elevation are adequate for structural stability. The use of techniques such as georeferencing through materialized control points and processing with specialized software demonstrated high precision and efficiency in monitoring. This method proved to be a safe, fast, and cost-effective alternative compared to conventional approaches. It is concluded that employing advanced technologies in dams can mitigate the risks of structural failures and sign

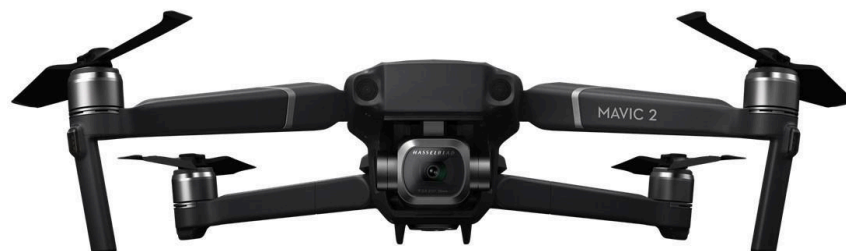
Figure 1. UAV equipment

For the execution of the photogrammetric aerial survey, a rotary-wing UAV, model *Mavic 2 Pro*, manufactures by *Dji*[®], was used. This equipment was provided for this research by ALM and is illustrated in Figure 1. The UAV is a small-sized, remotely controlled device equipped with an integrated camera capable of capturing high-resolution spatial images. The UAV characteristics are described in Table 1.

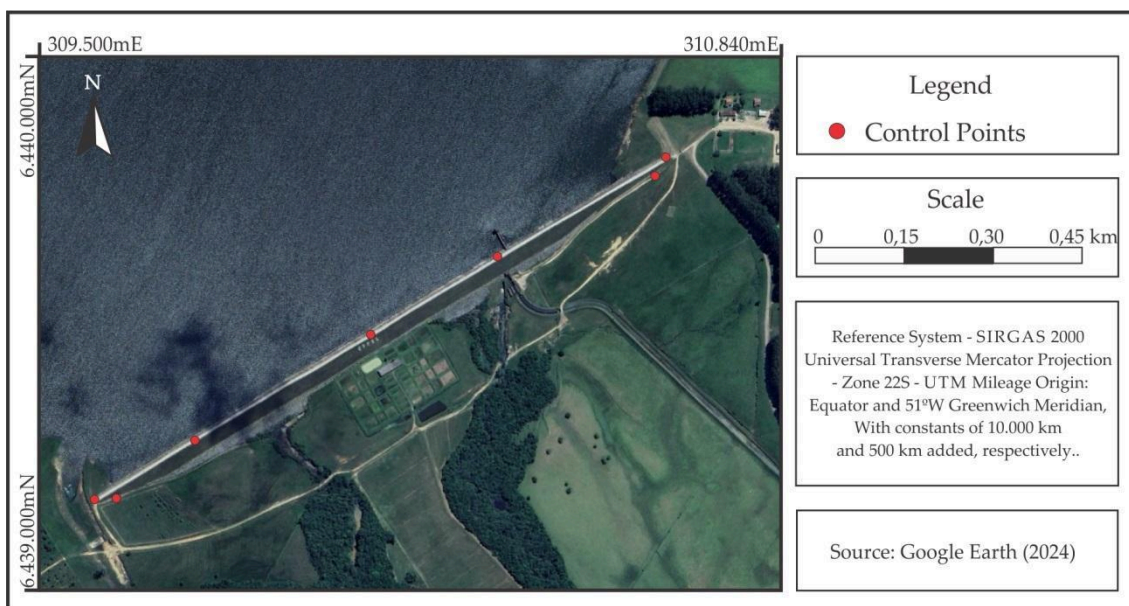
Figure 4. Map of control points location

Table 3 presents the location of the control points, using coordinates projected in the UTM system, defined at the central meridian 51°W, corresponding to zone 22, with orthometric altitudes. Figure 4 shows a map of the locations of these control points. The insertion of control points was carried out by identifying the targets in the images and manually translating the point onto the marked position.

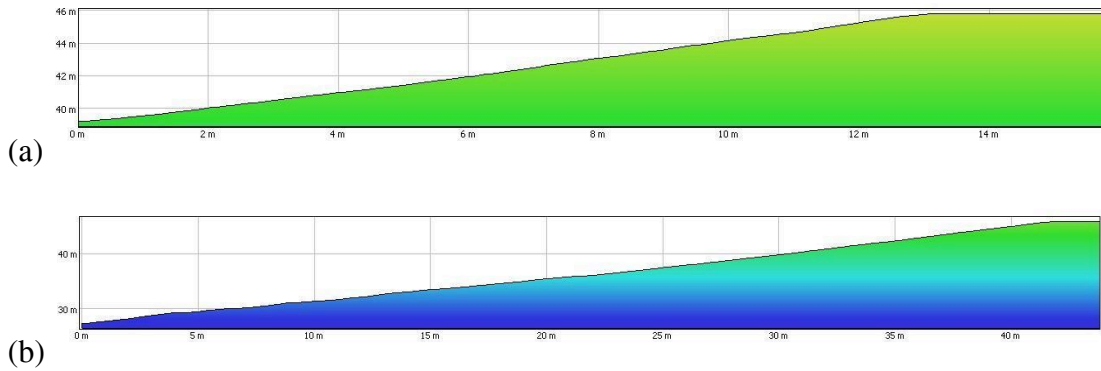
Figure 8. Longitudinal profile of the downstream slope obtained through DSM: (a) in a typical section fully above 32 m elevation; and (b) in a typical section with lower elevations

Figure 8 presents longitudinal profiles of the dam's downstream slopes. While Figure 8a represents a section entirely above 32 meters in elevation, Figure 8b corresponds to a section with lower altitudes. Since these profiles are directly generated by the *Metashape Professional*[®] software, it is not possible to edit the figure to accurately measure the slopes' inclinations.

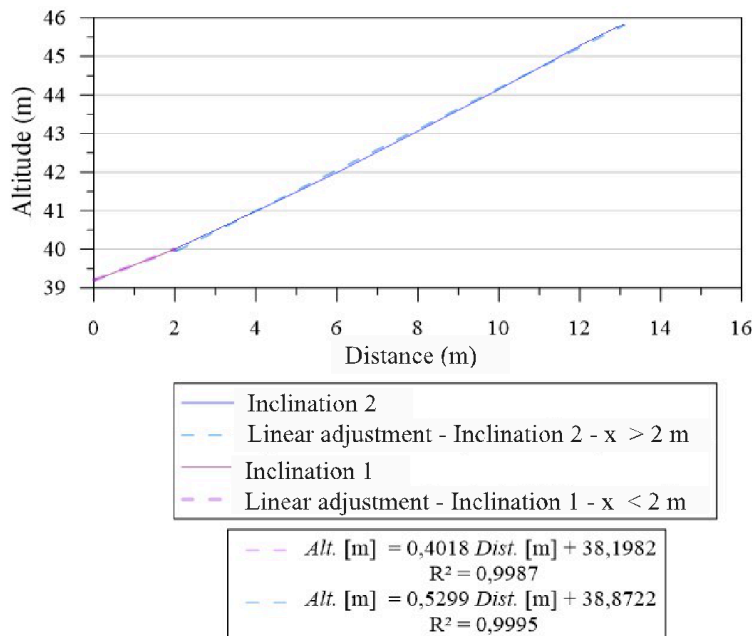
Figure 9. Incline of the downstream slope in a typical section fully above 32 m elevation

To address this limitation, the images were digitized using the Digitize function of the *Grapher*[®] software, which allowed for the creation of Figures 9 and 10. These figures display the linear adjustments used to calculate the slope inclinations, where Alt. represents the altitude and Dist. represents the distance. For accurate calculation, the graphs were truncated at the boundary between the slopes and the crest.

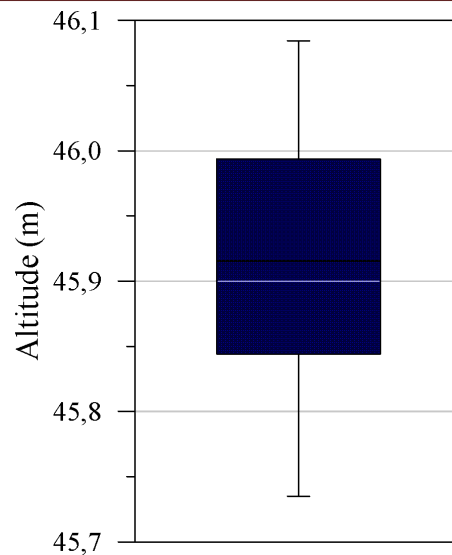
Figure 12. Altitude distribution

Figure 12 presents the statistical analysis of this data, based on 1,915 sampled points. It is observed that the median value is 45.91 meters, with the lower quartile at 45.84 meters and the upper quartile at 45.99 meters. Since no outliers were detected in the presented graph, it is understood that all portions of the dam's crest have altitudes greater than those specified in the basic design.
